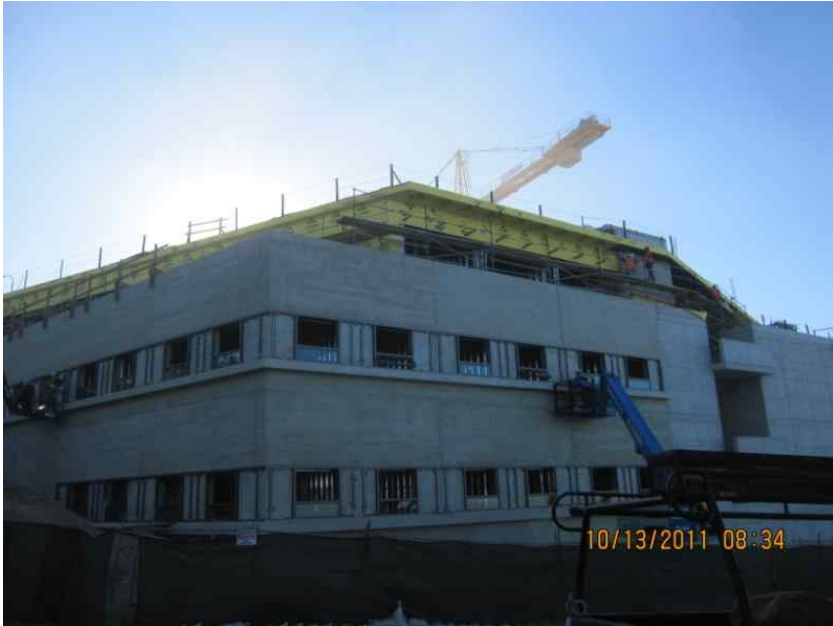
Levels 2, 3 and 4 as viewed from the northwest.

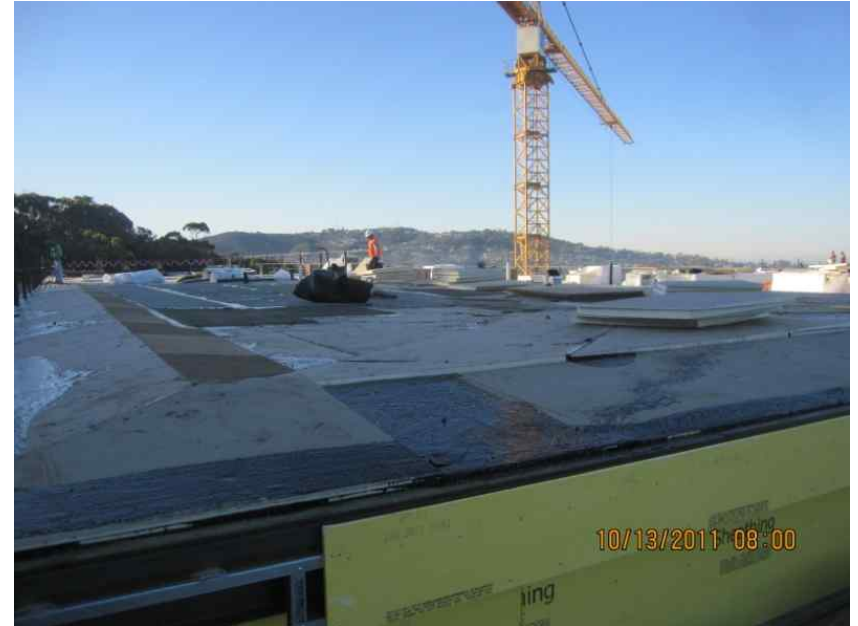
East wing Level 4 high roof.

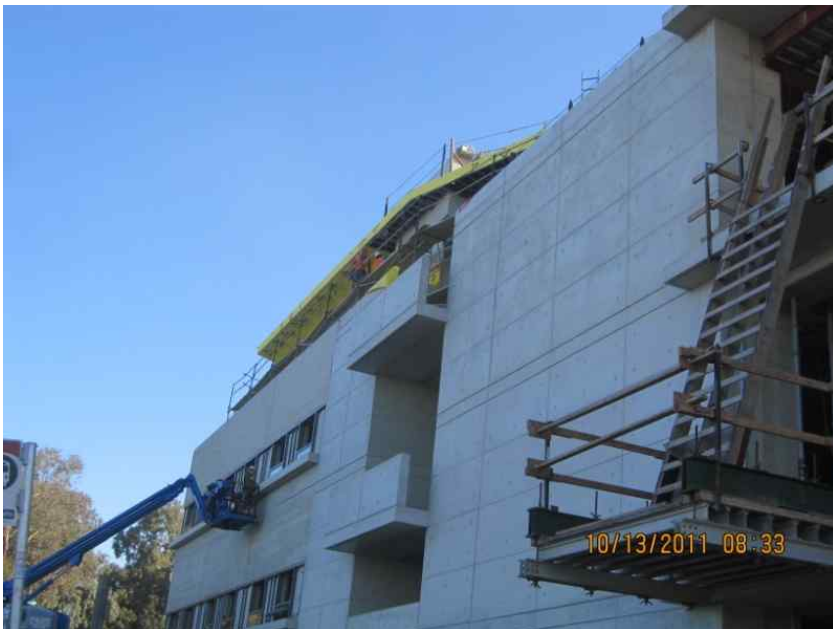
Window installation along level 3 at Grid V1

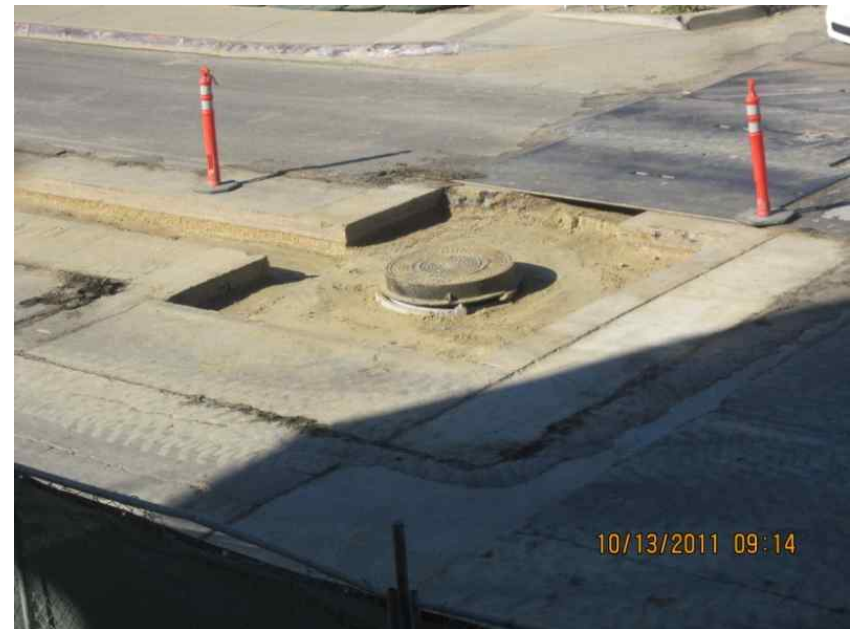
Excavation for concrete trench backfill within La Jolla Shores Drive

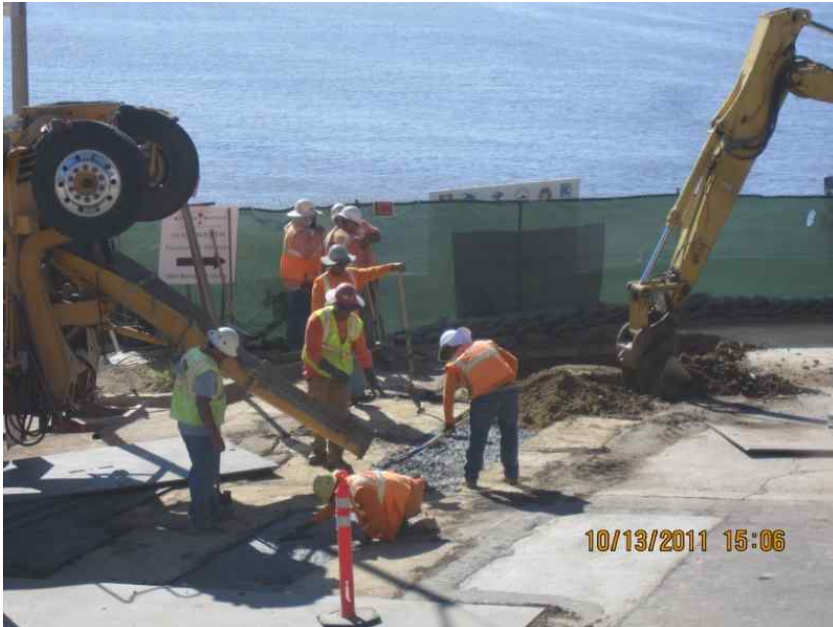
Placement of concrete cap for trench repair within La Jolla Shores Dr.

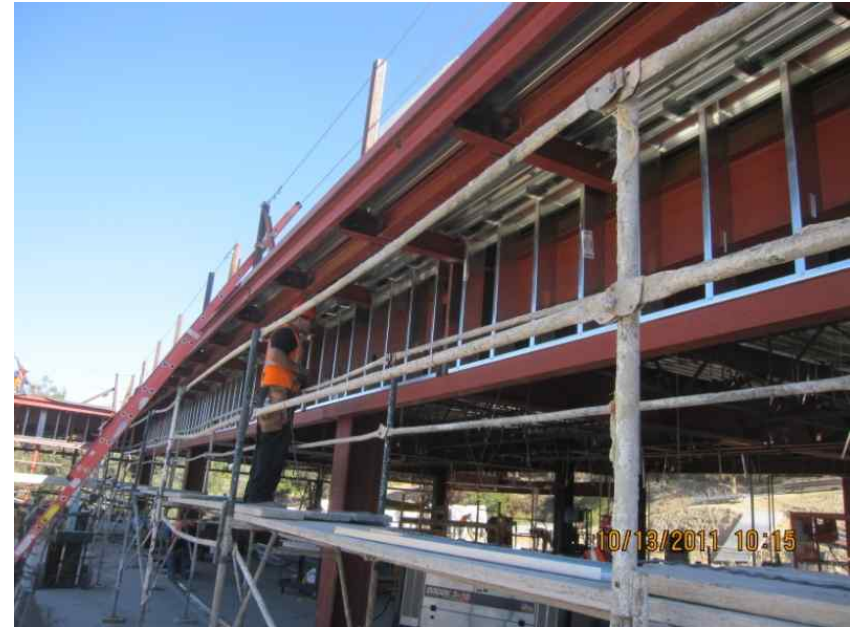
Level 4 exterior framing along Line V1.

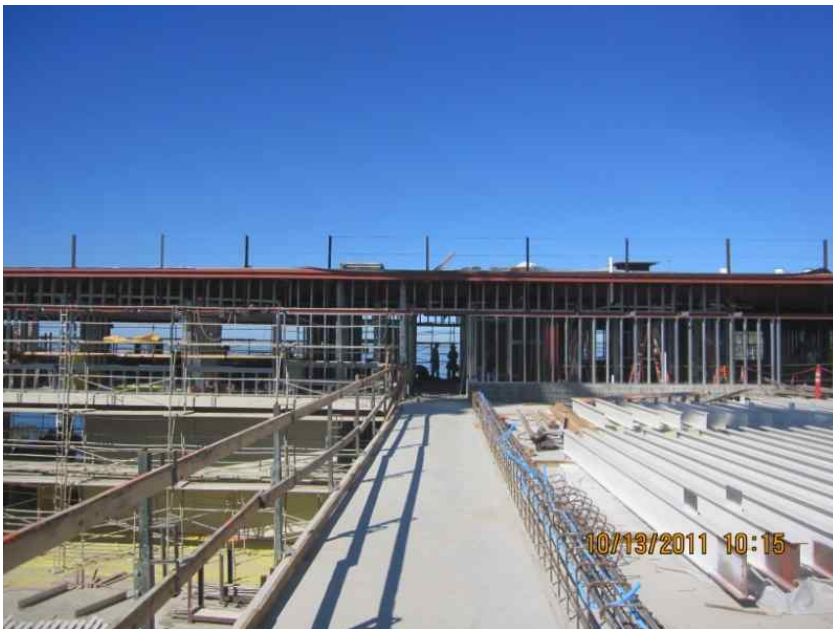
Level 4 framing along grid line W8.

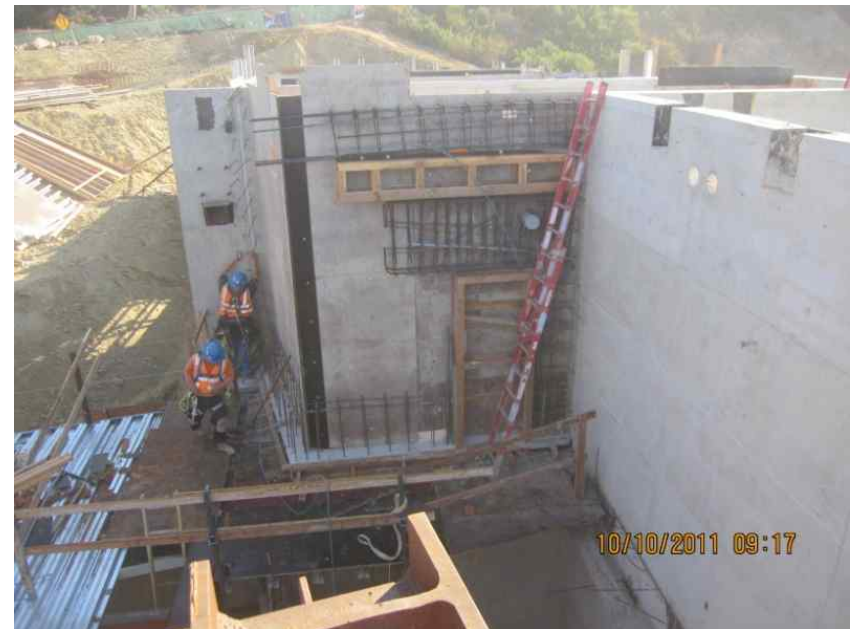
Setting reinforcing steel on Level 4 wall at Line 8.8.

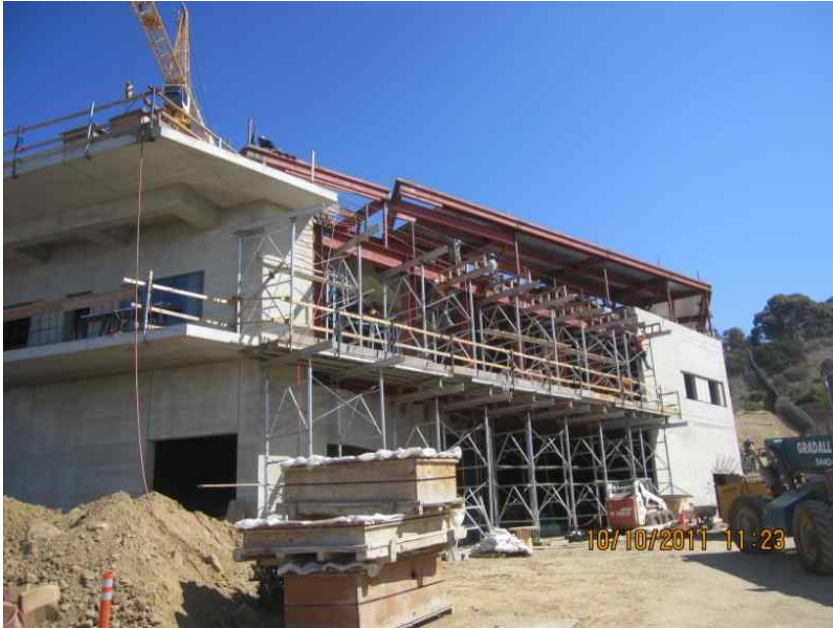
Southwest elevation of the building as seen from La Jolla Shores Drive.

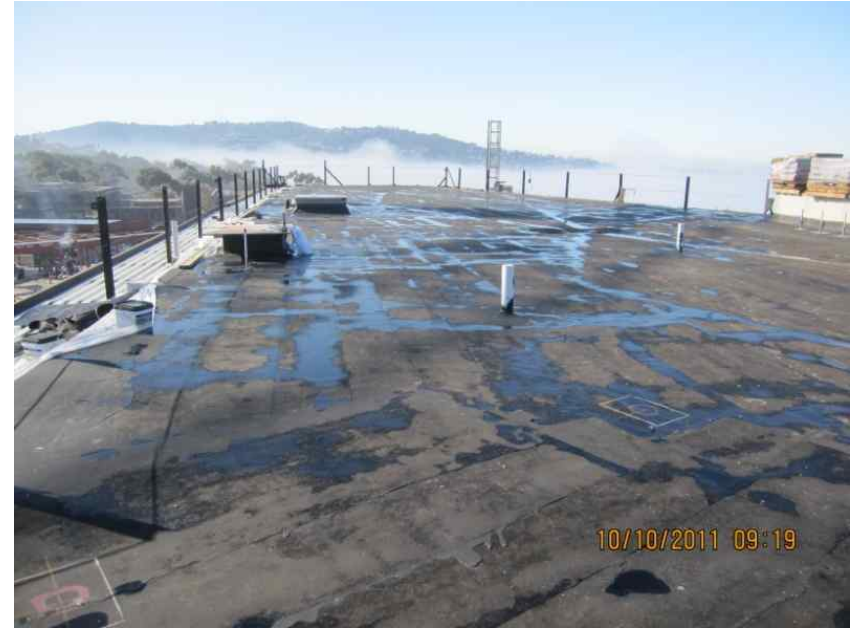
Level 4 west roof showing 'ponding' on roof.

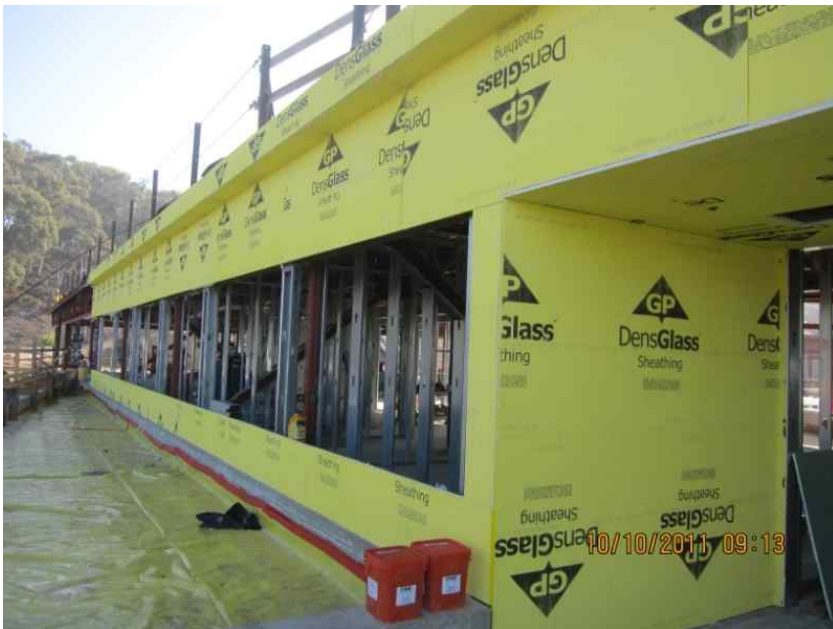
Level 4 sheathing along Line 1.

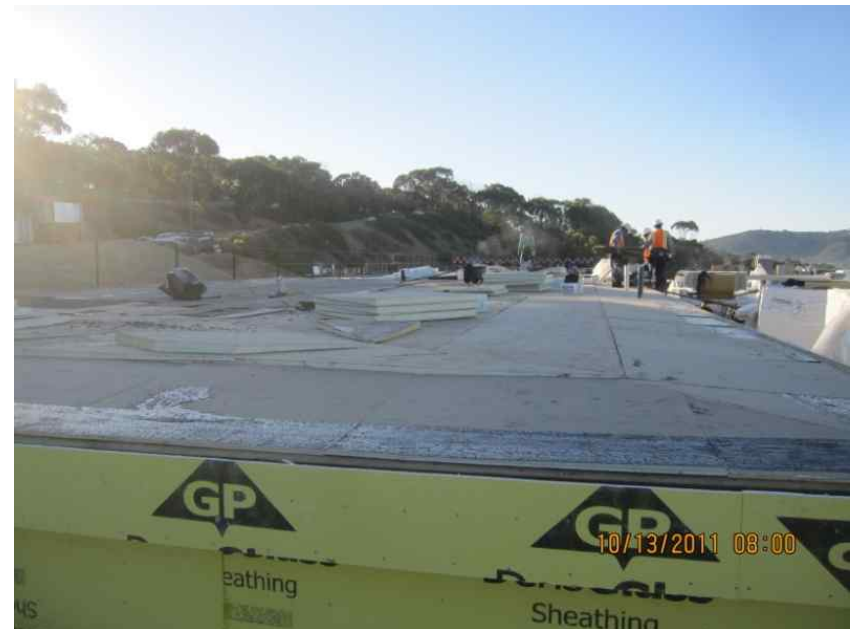
Level 4 sheathing, treated nailers and roofing along Line W5.

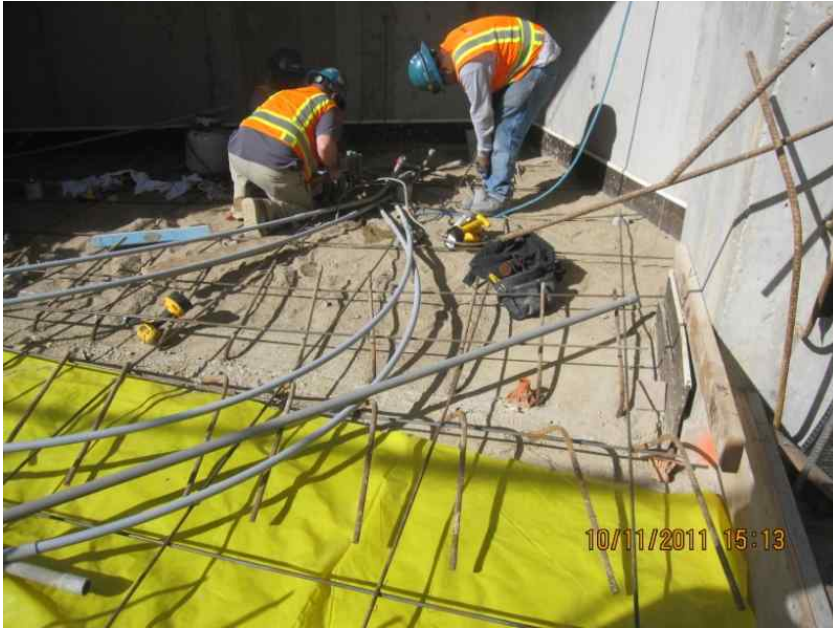
Level 1 generator pad reinforcement prior to placement of concrete.

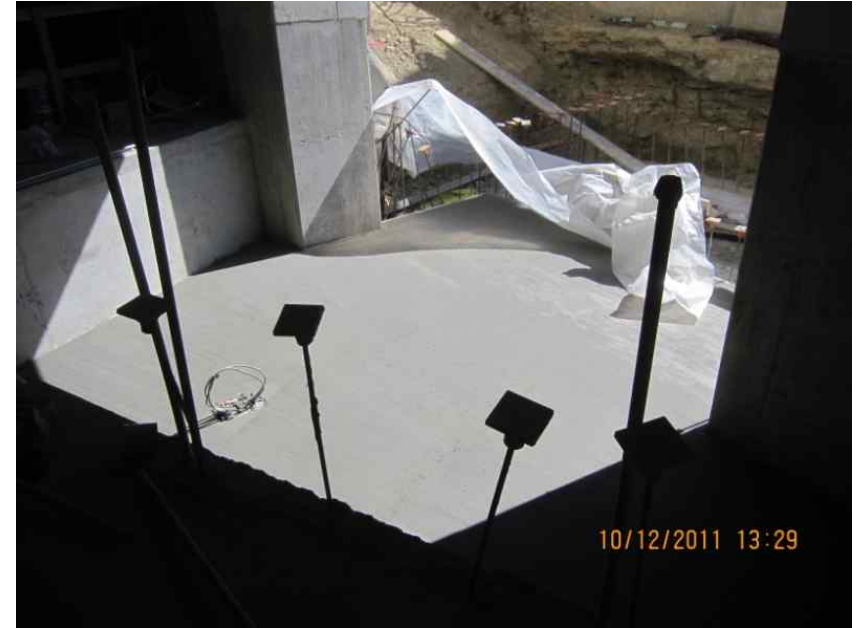
Level 1 generator pad after placement of concrete.

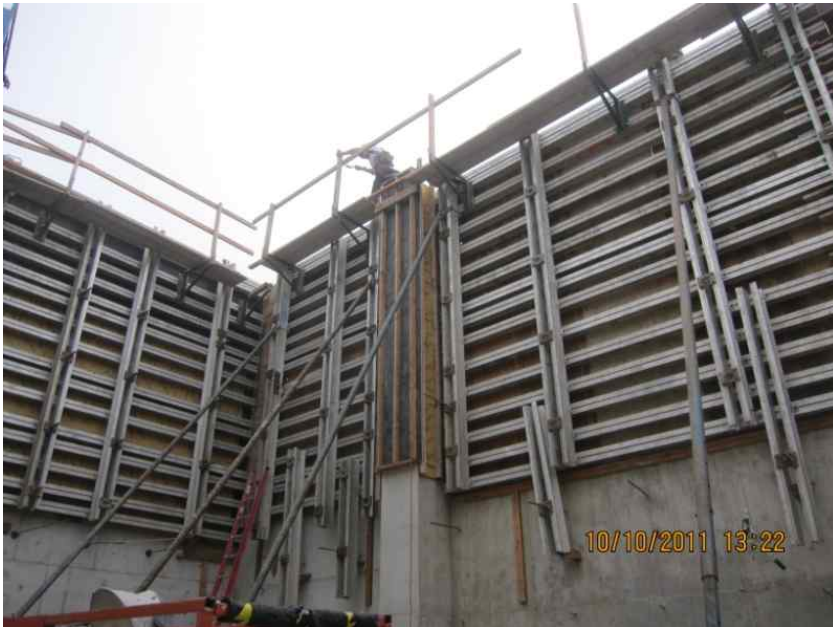
Level 4 wall forms along Line J and 9.1.

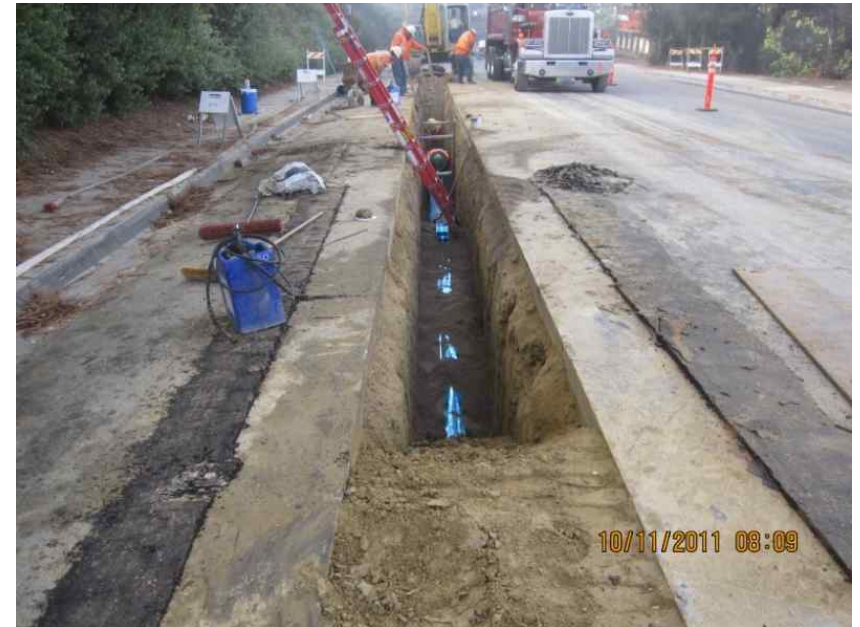
Installation of 12" waterline within La Jolla Shores Drive.

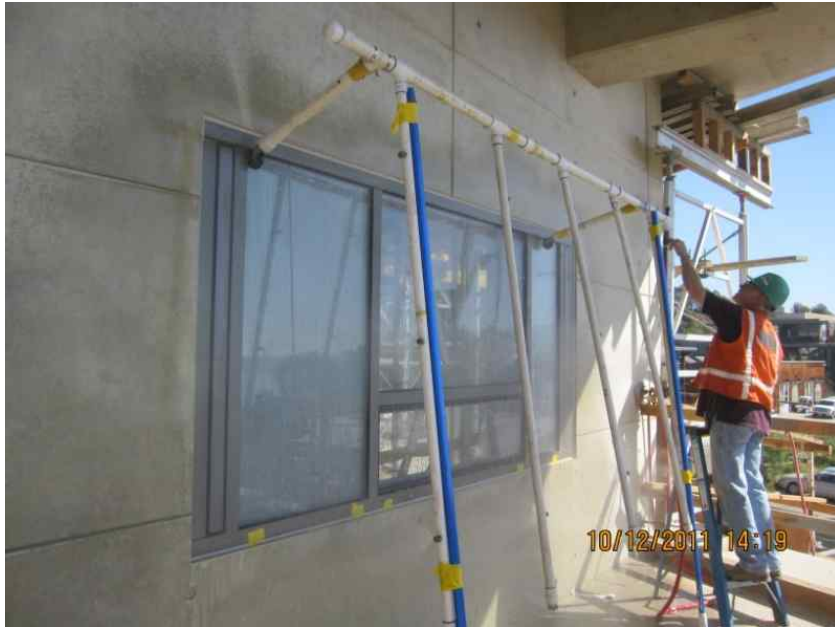
Testing of Level 2 windows along Line V1.

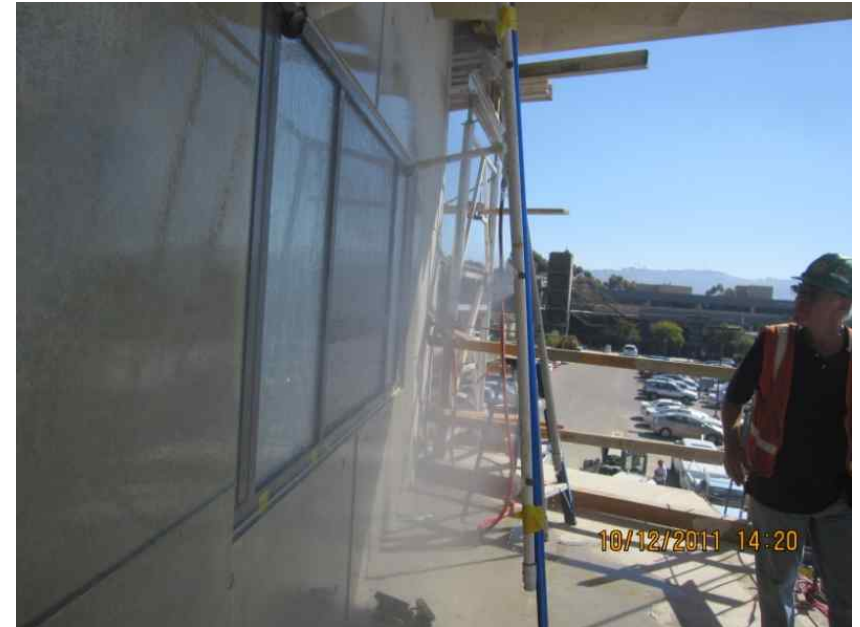
Testing of Level 2 windows along Line V1.

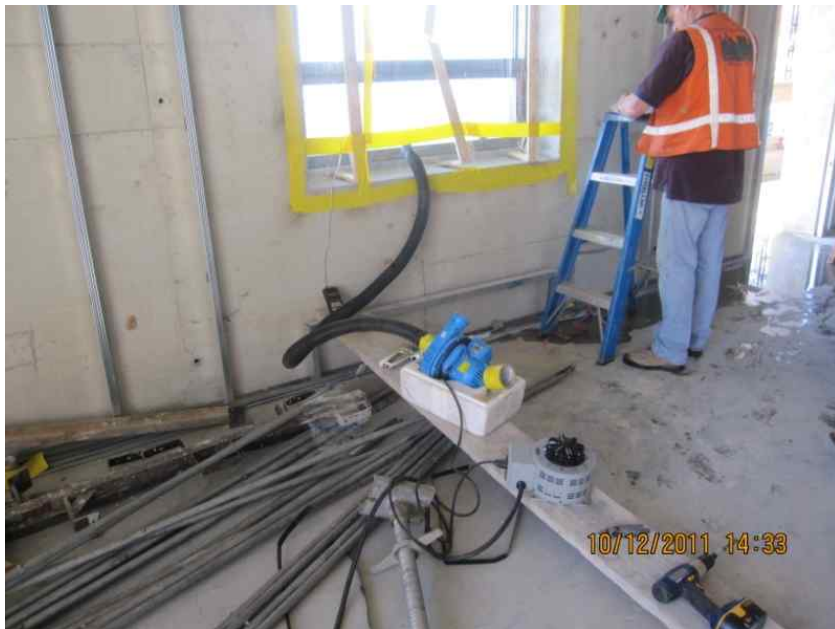
Testing of Level 2 windows along Line V1.

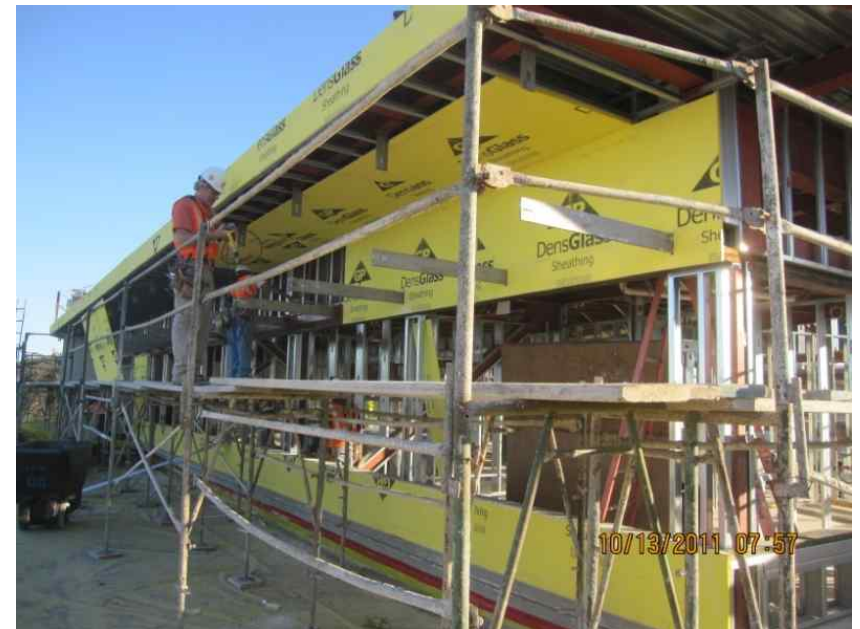
Sheathing and stainless steel shade support on Level 4 at Line V1.
